HLH/ATC ENGINE SHAFT SUPPORT BEARING
DEVELOPMENT PROGRAM

Boeing Vertol Company

May 1974

4. TITLE (and Subtitle) HLH/ATC ENGINE SHAFT SUPPORT BEARING DEVELOPMENT PROGRAM		5. TYPE OF REPORT & PERIOD COVERED Final Test Results and Technology Development

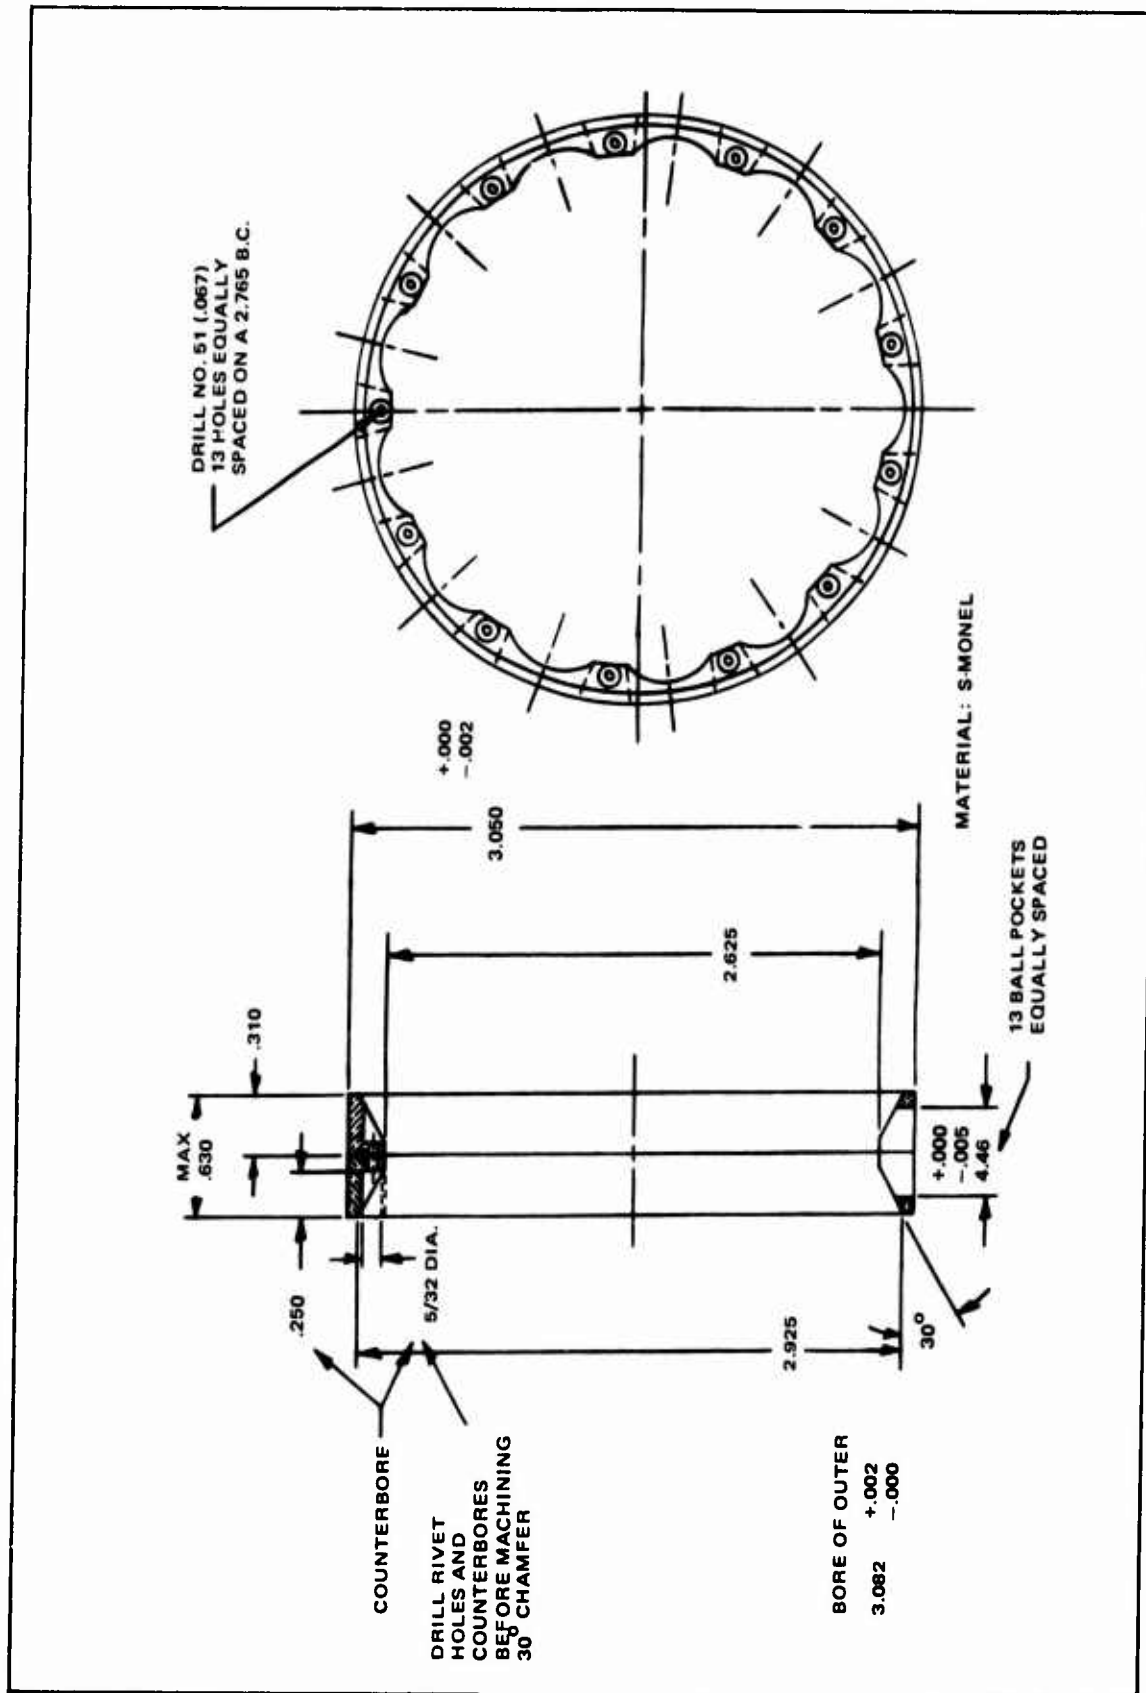
Figure 12. Machined Outer-Land-Riding S-Monel Cage.

An outer land riding S-Monel cage (Figure 12) was designed and fabricated after significant wear was observed in the inner land riding specimens. The rationale involved the action of centrifugal force on an unbalanced cage; an inner land riding cage tends to wear only in one area, with rate of wear increasing as the cage becomes more and more unbalanced. An outer land riding cage tends to wear more evenly about its periphery, although other factors, such as the tendency of an outer land riding cage to trap lubricant in the outer race, mitigate against its universal use.

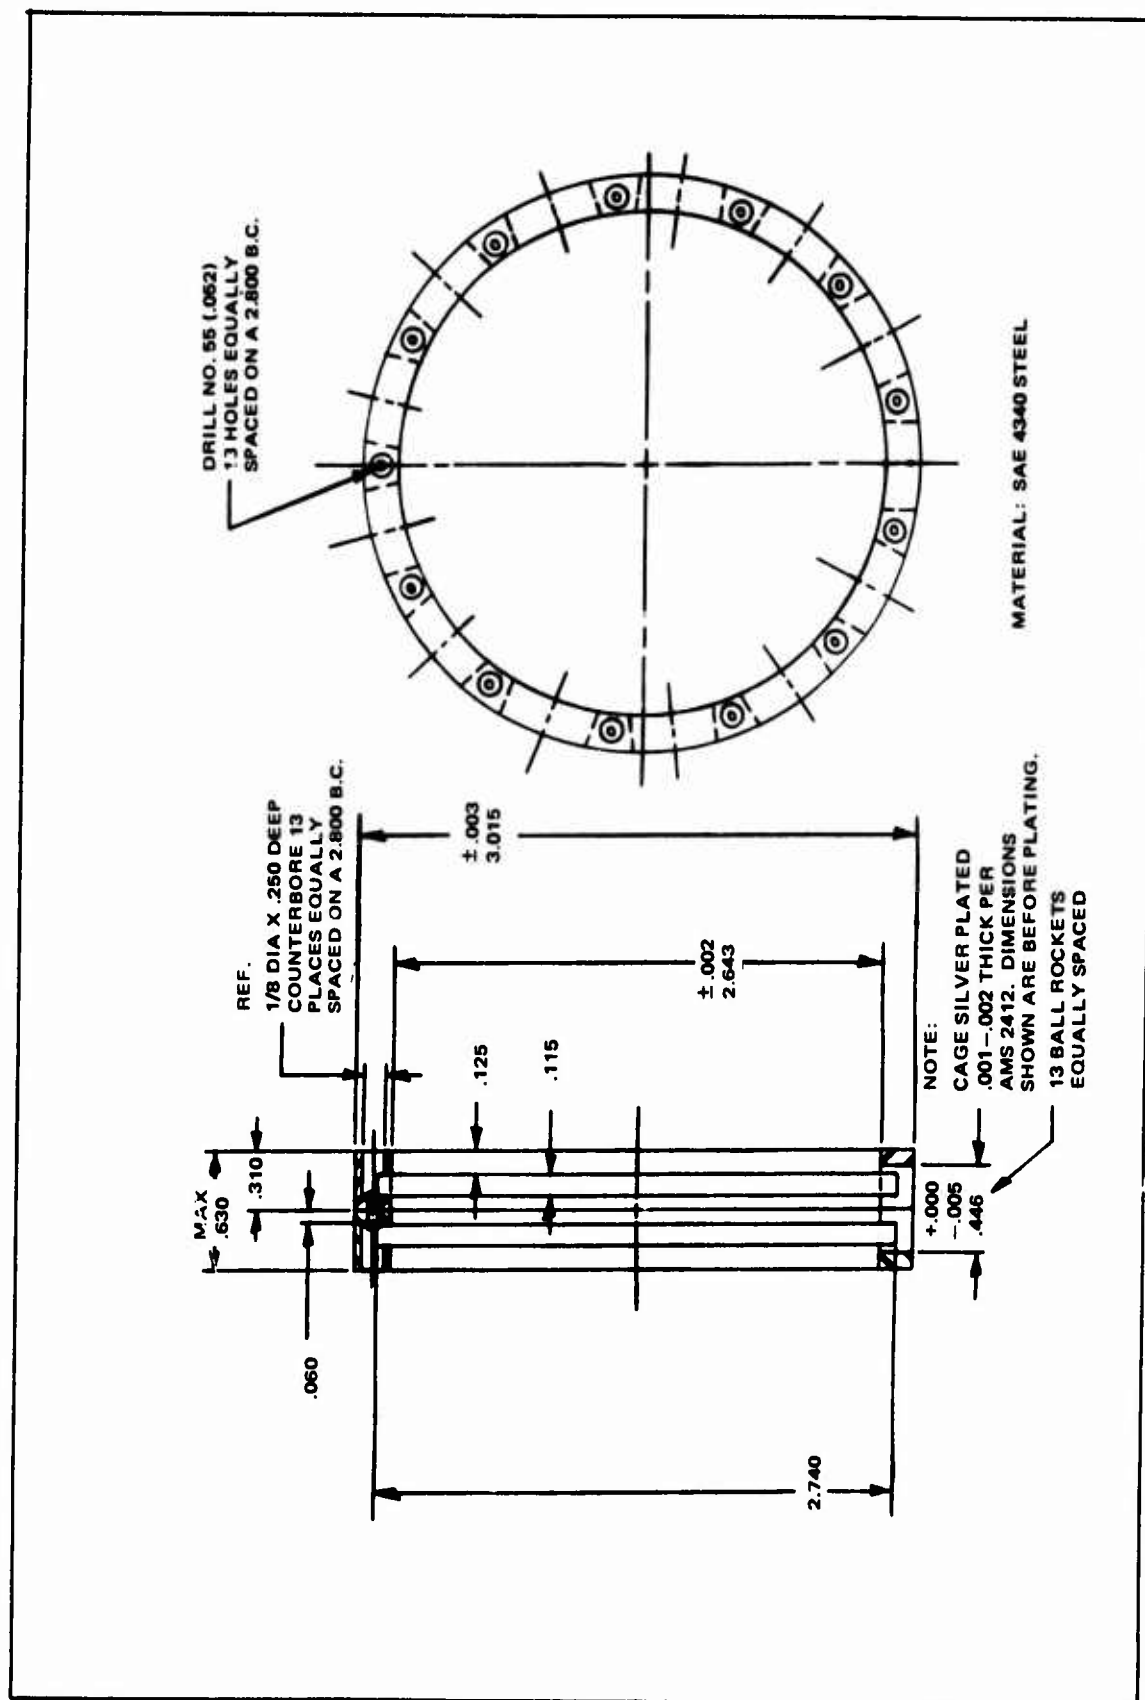
Figure 13. Two-Piece Machined Steel Cage, Silver Plated.

After severe wear, indications of inadequate grease circulation, and fracture of a number of cages occurred during testing, a silver-plated machined steel cage (Figure 13) was designed and fabricated. The rail section and short rivet design were incorporated for high strength; the silver plate provided some marginal lubrication; internal annular grooves provided space for grease circulation around the inner race.

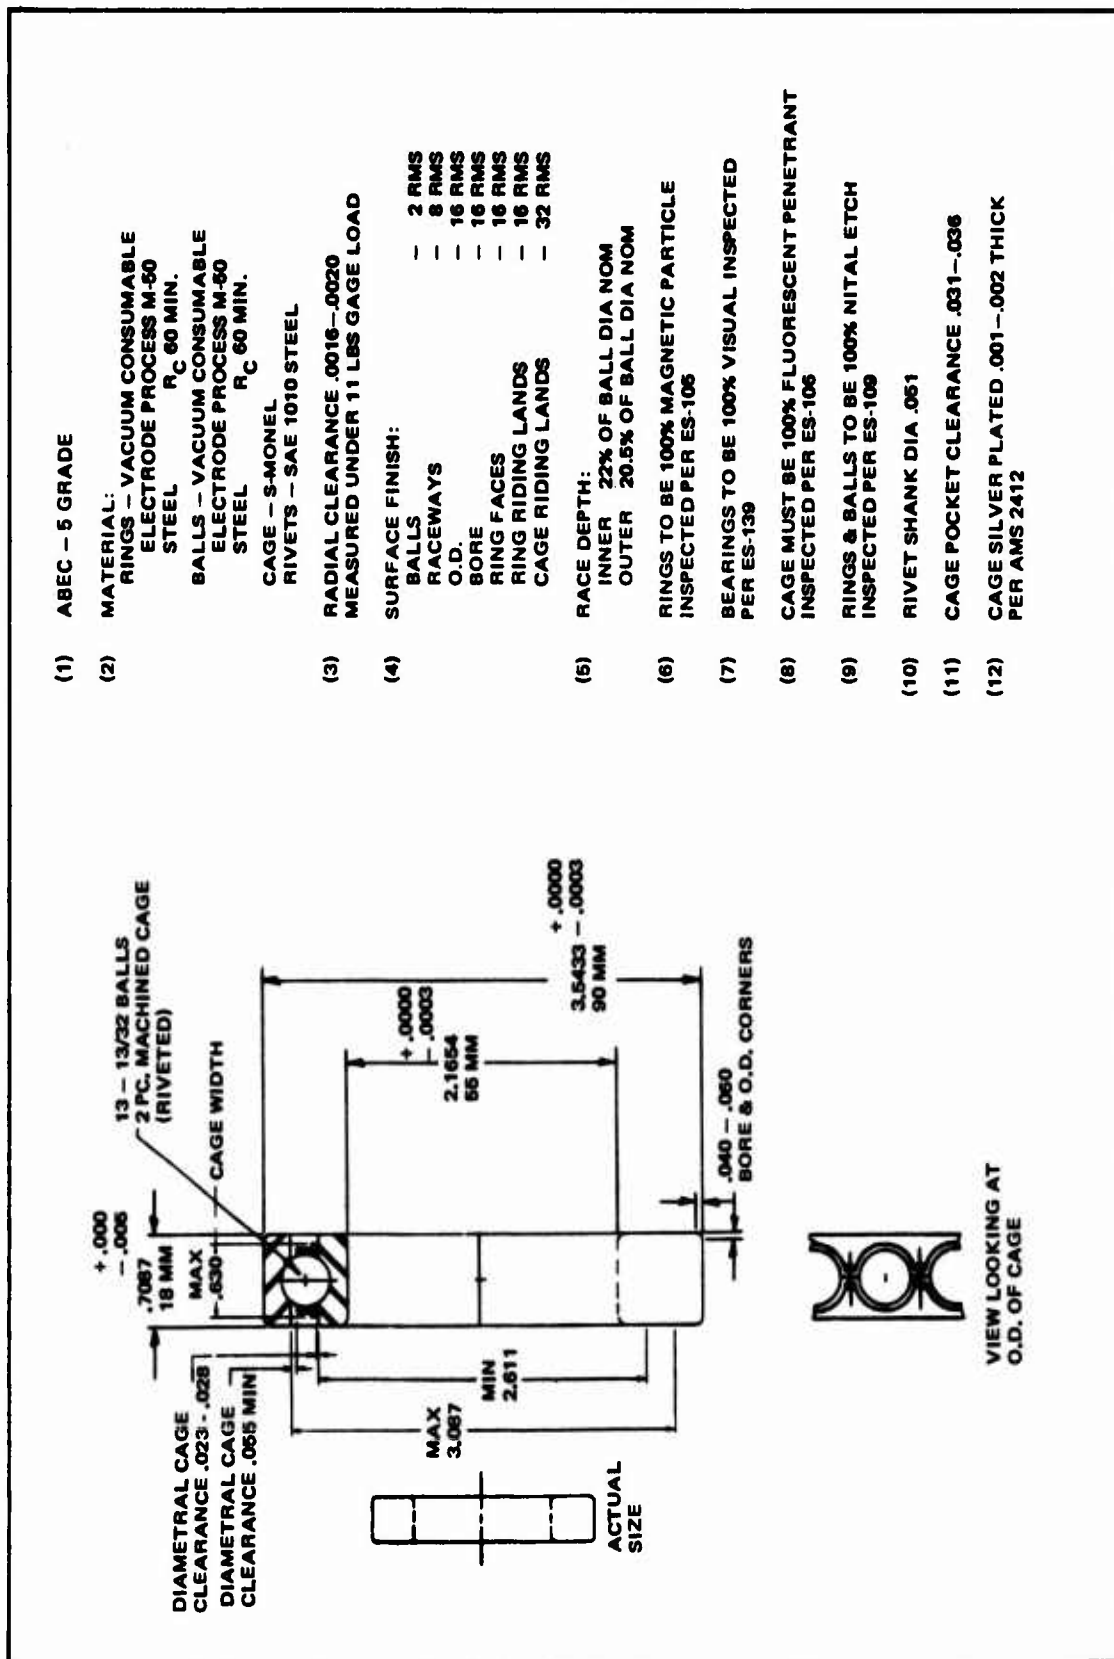
Figure 14. Modified 111-KS Test Bearing.

Because of continuing difficulty in achieving a successfully operating bearing for 300 hours, two MRC 111-KS ball bearings conforming to Figure 5 were obtained and modified as shown on Figure 14. The radius of curvature of the inner races was changed to 53% of ball diameter, and that of the outer races was changed to 54% of ball diameter. The raceway curvatures used in previous testing were 52% of ball diameter. One inner ring was coated with Teflon-S on its land surfaces. Cages conformed to Design 3 of the inner-land-riding S-Monel configuration.

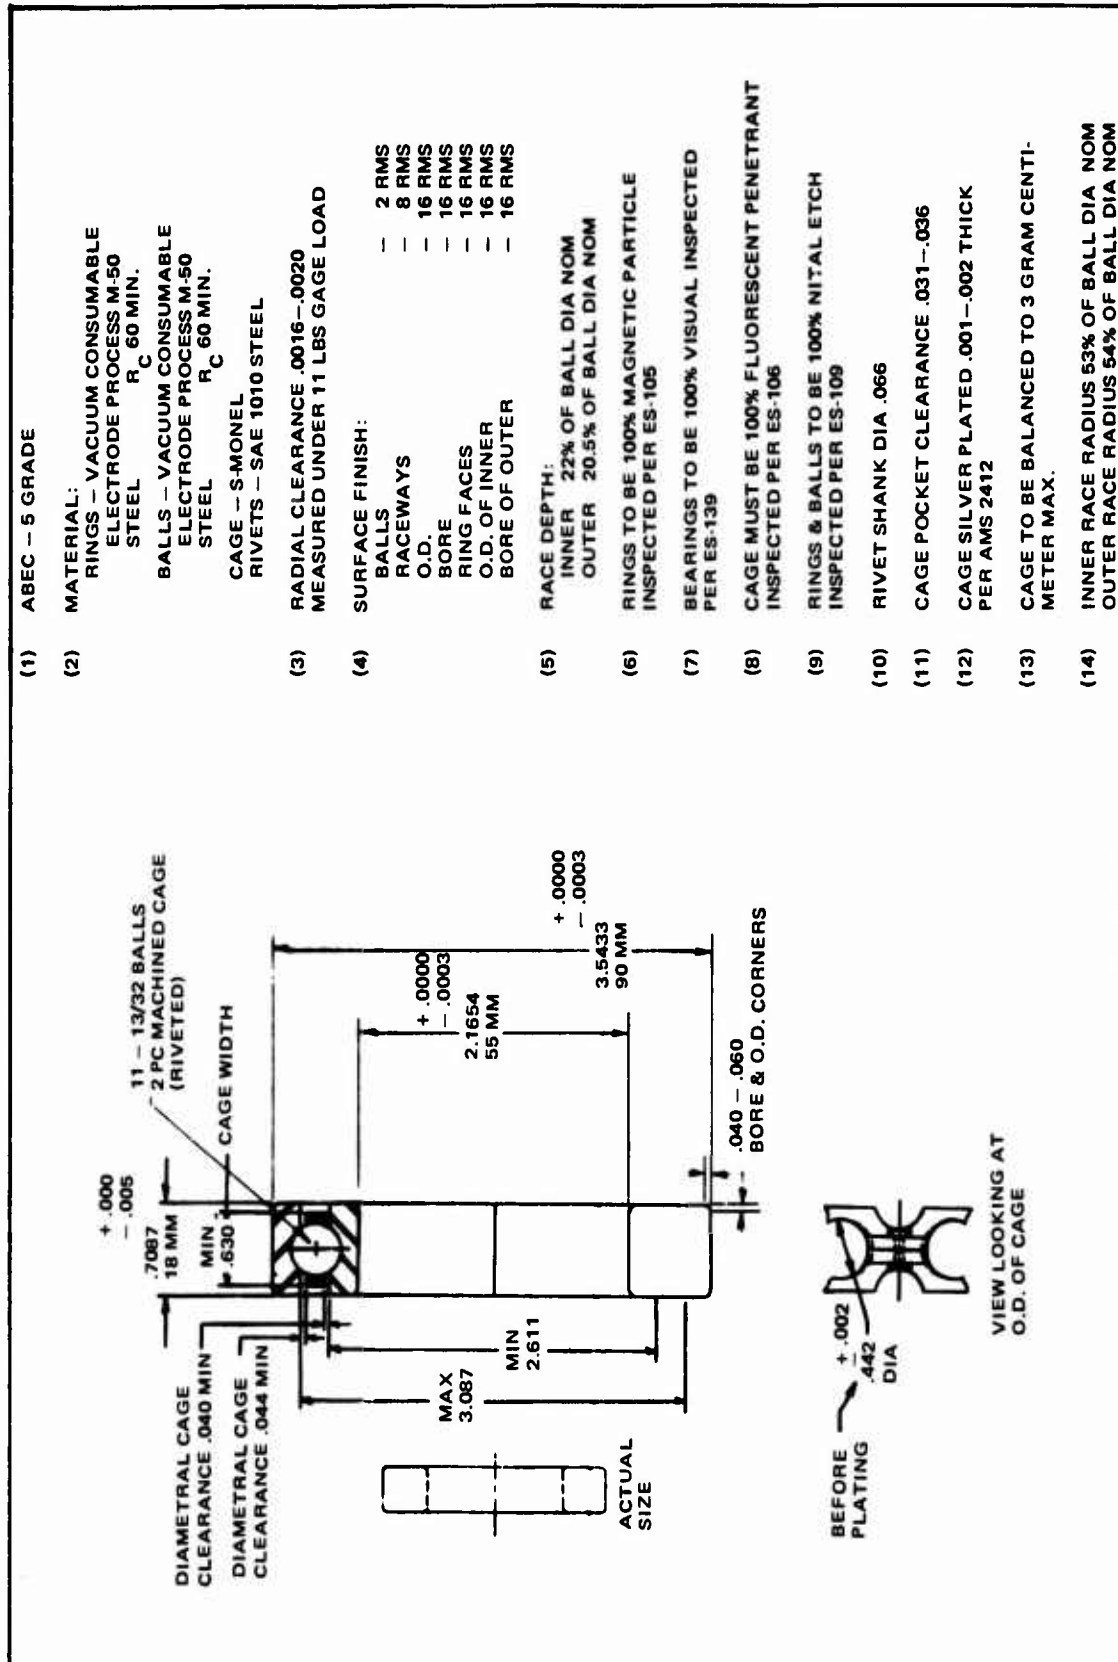
Figure 25. Modified Test Bearing, Cage Design 6.

- Two bearings were fabricated to the configuration shown in Figure 23. The inner race cage riding lands were coated with "Sermetel 72", by Sermetel Division, North Wales, Pennsylvania. The coating was a final attempt to reduce the severe cage land wear experienced during prior testing.
- A major review of all the cage designs tested indicated that the original ball riding, pressed steel cage appeared to operate satisfactorily under the specified test conditions. Therefore, a machined ball riding cage (Figure 24) was designed and fabricated. This final cage design was assembled into the bearing configuration shown in Figure 25.

Test bearing S/N 1 and 6, conforming to Figure 25, were installed in Machine A. These bearings had both been run 300 hours under the same test conditions in Machine B.

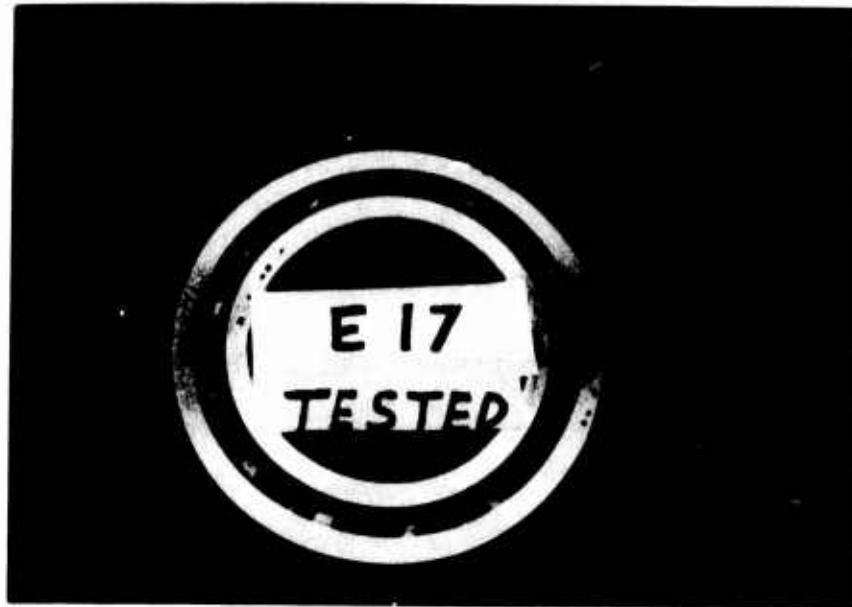
Figure 48. Bearing S/N E17 After Test, Several Rivets Lost.

This test evaluated bearings S/N E4 and E17 with the original (Design 1) inner land riding S-Monel cage and the grease circulating device in a housing. Both housings were initially packed with 7 ounces of grease. At 178.0 hours and 278.8 hours, it was necessary to regrease the drive-end housing, using 6-1/2 ounces each time. No regreasing was necessary in the outboard housing, and it had 5 ounces left at the end of 300 hours. The bore of the cage of the drive-end bearing had worn to a maximum depth of 0.040 inch. The cage in the outboard bearing had worn relatively uniformly 0.010 to 0.014 inch on the diameter, but it lost 5 rivets and 2 others were loosened.

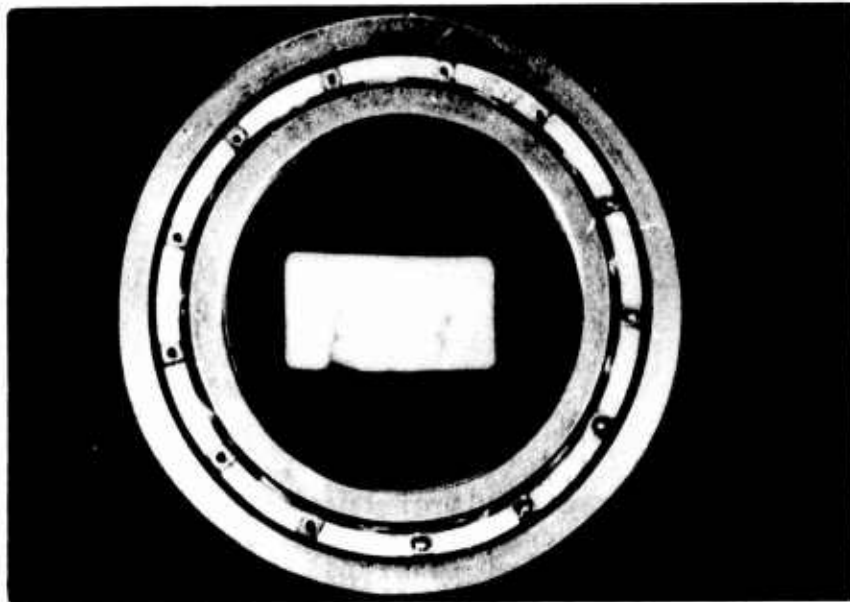
Figure 51. Bearing E13 After Test (Some Rivets Have Been Removed for Disassembly).

Erratic performance of bearings resulted in several teardowns and inspections, so housing and seal evaluations were impossible. Basically, the bearings had difficulty getting enough grease and were partially starved. Their torque tended to be high or to vary, causing the shaft to change its misalignment, and causing the close-running labyrinth seals to contact the shaft. The test was terminated prematurely, and bearings were inspected. Balls and races were cloudy, indicating surface deterioration. Figures 50 and 51 show one of these bearings before and after test.

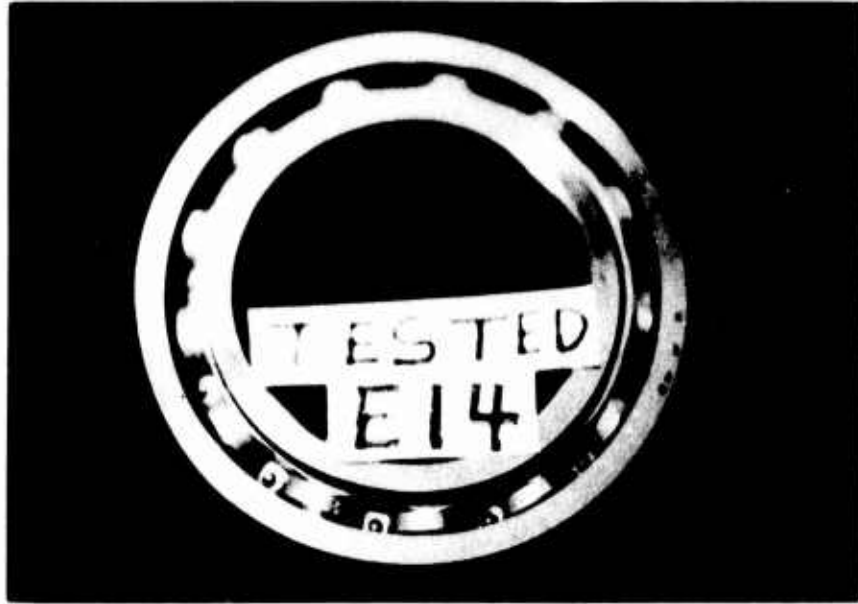
Figure 53. Bearing E14 After Test.

After 300 hours the test was suspended. Both bearings had worn on the bore, with the heaviest wear, approximately 0.035 inch, in the drive-end bearing. The outboard bearing had experienced maximum depth of wear of 0.018 inch. Neither cage had lost rivets. Figures 52, 53, and 54 show a bearing before test and the 2 bearings after test.

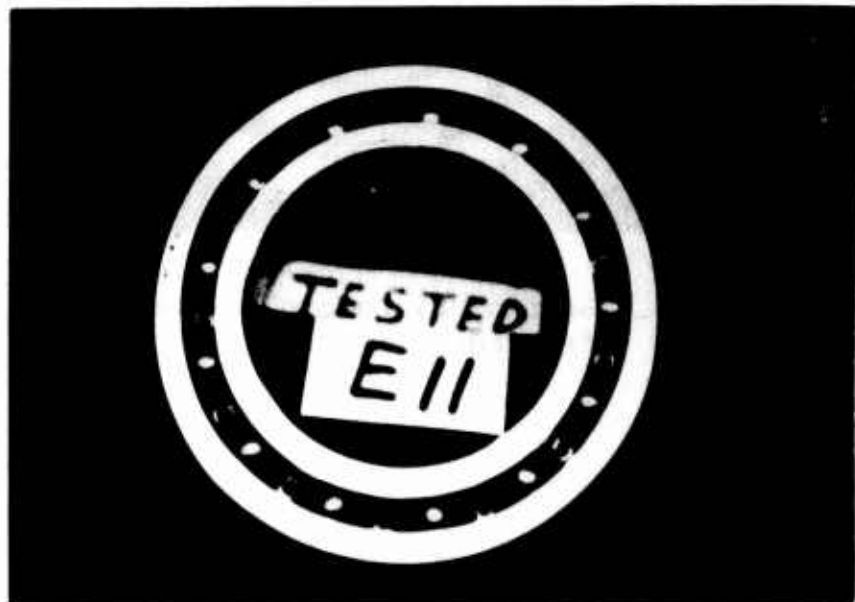
Figure 57. Bearing E11 After Test.

During the last several hours of operation, performance of the drive-end bearing was erratic, and the grease additions to this position were attempts to stabilize it. At 246.2 hours the rig was shut down and disassembled. The cage in the drive-end bearing was found to have lost all rivets and separated. The outboard end bearing was still intact. Figures 55, 56, and 57 show the bearing with Teflon-coated cage before test, and two bearings after test.

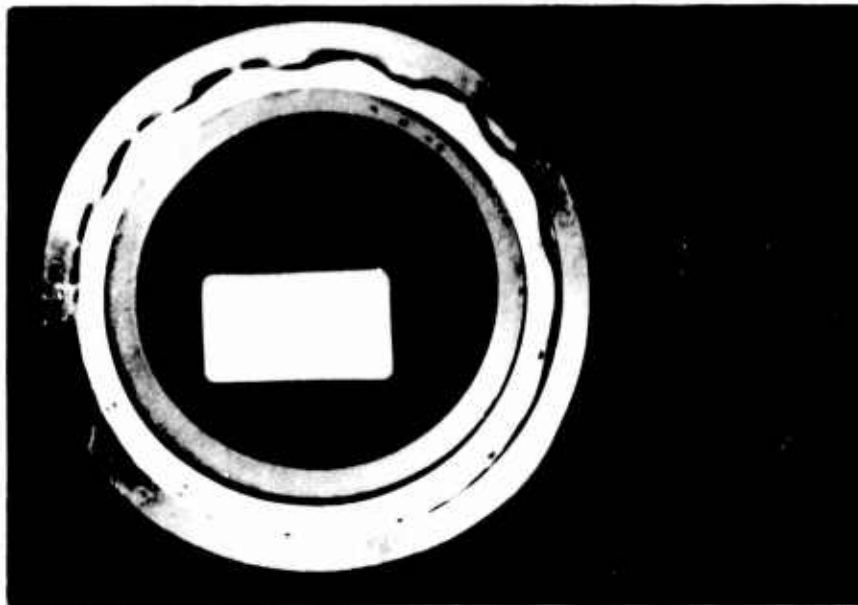
Figure 66. Bearing E20 After Test.

The outboard bearing (S/N E20) with Design 3 cage (Figure 65 before test, Figure 66 after test) wore through the silver and into the base metal in the land contact area to depths of 0.007 inch on one half and 0.015 inch on the other. The O.D. of the cage had not contacted the outer lands. Balls had not worn through the silver on the pockets. There appeared to be a trace of Teflon left on the inner lands, embedded in the surface finish.

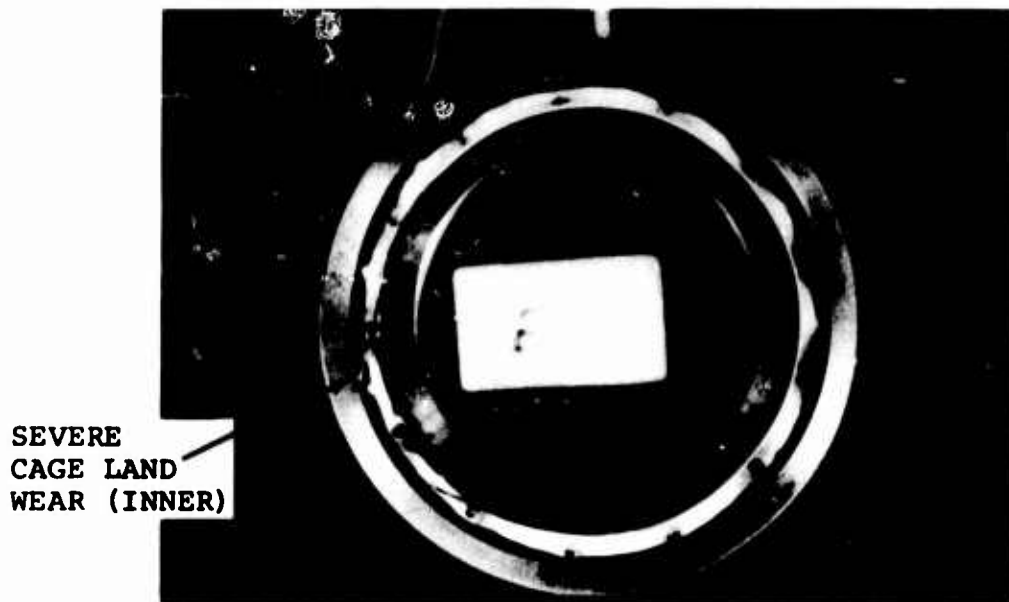
Figure 68. Bearing E15 After Test.

The inboard bearing (S/N E15) with Design 4 cage (Figure 67 before test, Figure 68 after test) wore to a maximum depth of 0.025 inch in the land riding surface, and this surface broke through. The O.D. of the cage had contacted the outer lands 180° from the area of heavy wear. Balls had not worn through silver in the pockets. The inner lands had no more than a trace of the Teflon coating left.

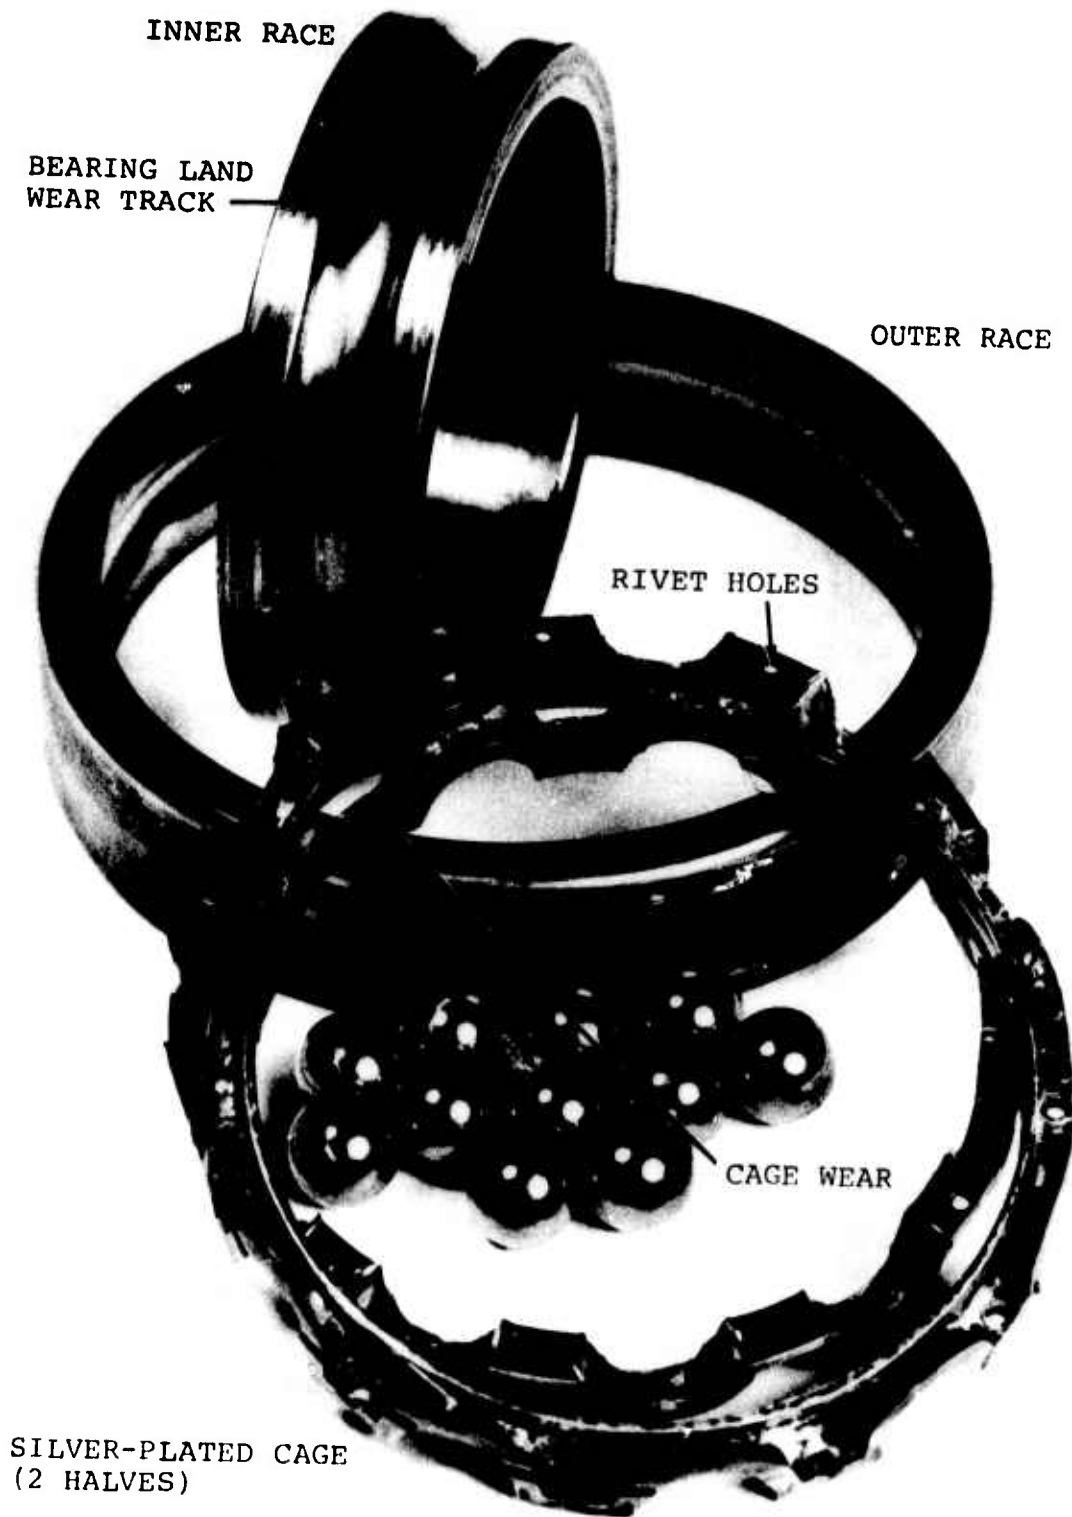
Figure 76. Drive-Shaft Support Bearing S/N 2, Drive End After Test.

Inner and outer races of the drive-end bearing looked surprisingly good, with a few small skid marks at the bottom of the inner race. Both race paths were wide, indicating operation in a variety of thermal and clearance regimes. The Sermetel 72 coating on the inner ring lands appeared to be largely eroded. Figure 76 shows the components of bearing S/N 2 after test.

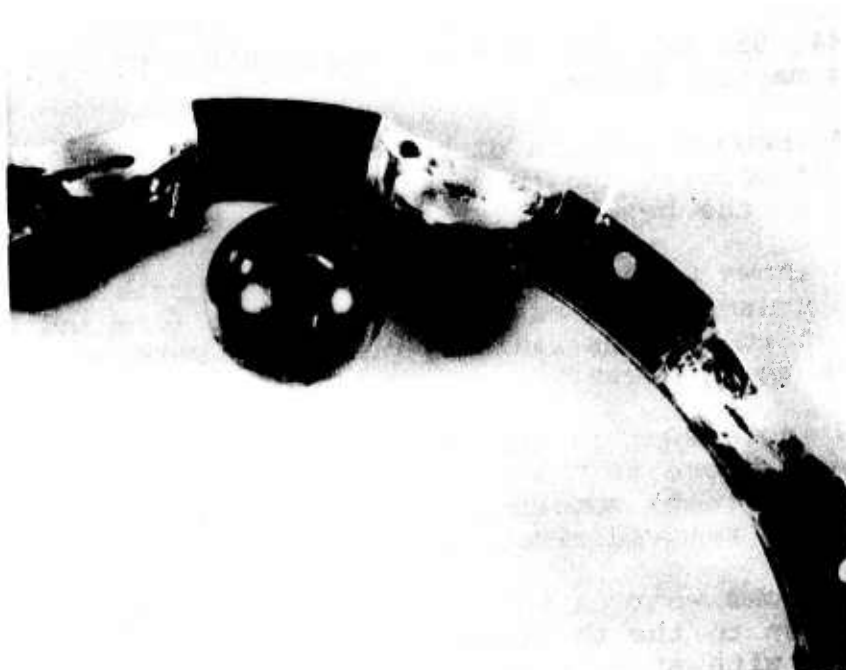
Figure 85. View of Cage Pockets and a Ball, Bearing S/N 6.

Figure 85 shows wear in the ball pockets. This wear is concentrated around the bore of the cage, but fore and aft in each pocket it extends radially outward. Dark grease residue remains in the pockets.
